LA CIENEGA ACEQUIA
286-384 Los Pinos Road
Santa Fe
Santa Fe County
New Mexico

HAER NM-14
NM-14

LA CIENEGA ACEQUIA

HAER No. NM-14

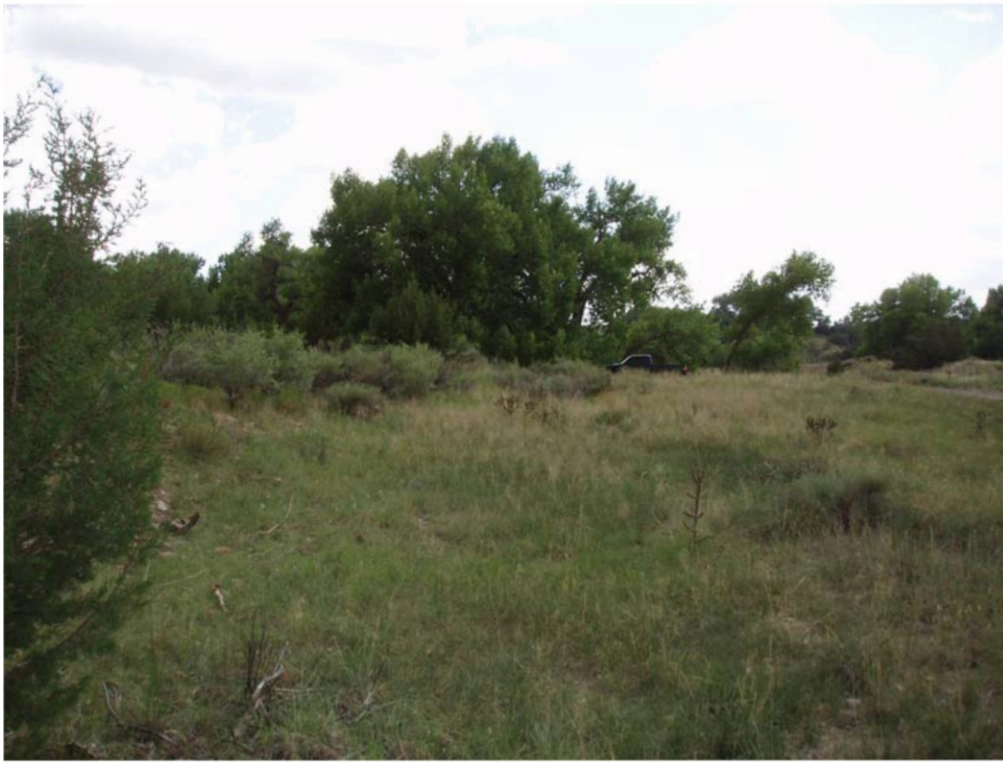
Abandoned Acequia A1 is located above the confluence of Arroyo Hondo and Arroyo de los Tanques (Figure 3). This ditch is about 89 m (291') long and runs at an elevation about 1 m (3.3') lower than the active acequia. It varies in cross section profile from a 1-to-2-m (3.3'-to-6.6') wide terrace, to a ditch 1 meter (3.3') wide and about 20–40-cm (8"-16") deep. The remains of a check (Feature 32) are at the northeast end of the ditch near an active spring (Figure 4). The check is constructed of two 1" angle irons standing on end, about 1' apart. The check was operated by hand, but the remains of the gate are missing. The south end of the ditch is truncated by a bladed road, while the north end is truncated by erosion on the terrace.

Figure 3. Abandoned acequia alignment (A1). Photo by J. Robert Estes, 2007.

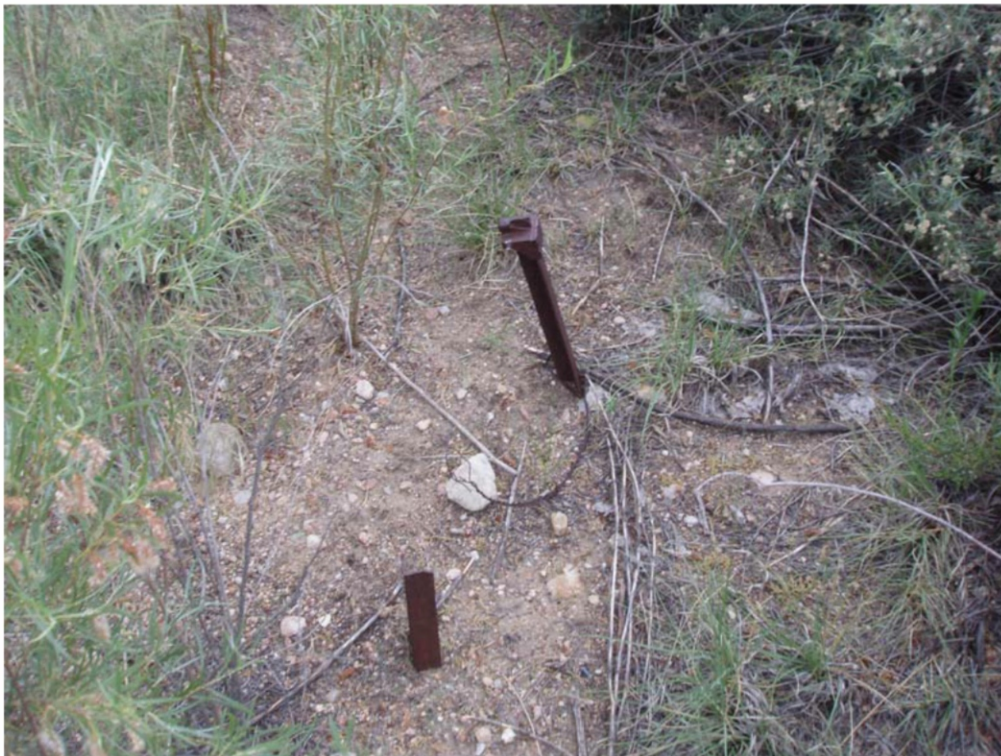
Figure 4. Feature 32, frame for abandoned check/*compuerta*. Photo by J. Robert Estes, 2007.

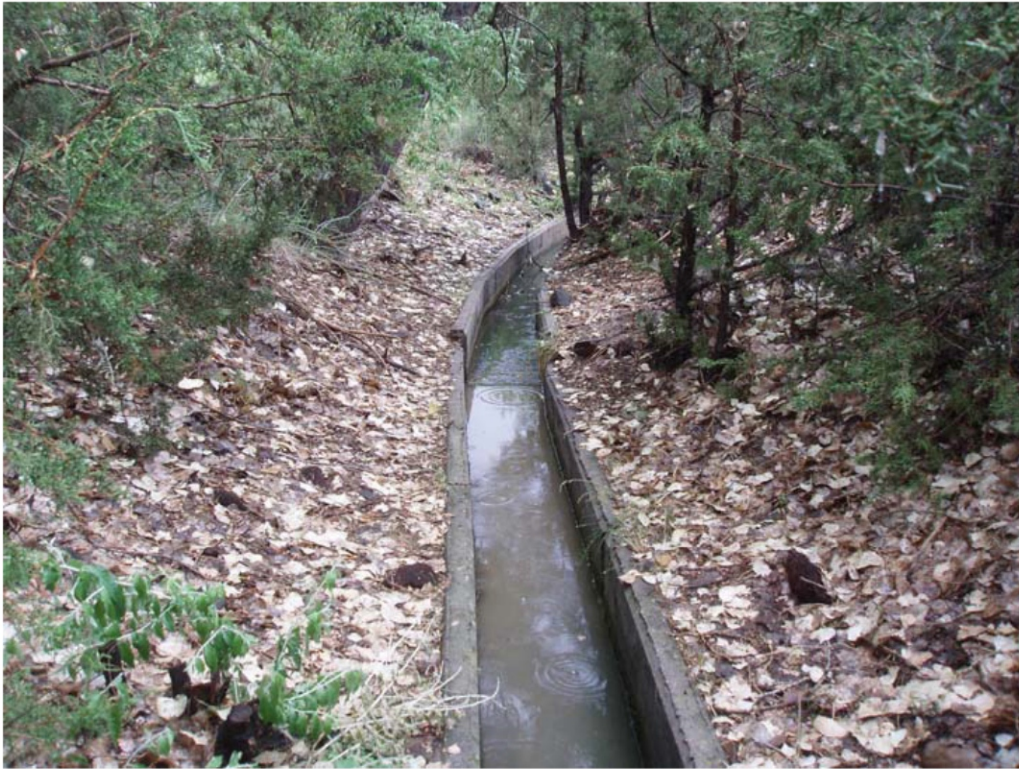
Abandoned Acequia A2 runs west in discontinuous segments along the north terrace of the Arroyo de los Tanques. It then turns to the north along the terrace, where it fed an abandoned earth tank. Portions of this ditch have been completely washed out by flooding. The ditch bank is eroded into a low, linear mound or is completely destroyed. Its cross section is a 1-to-2-m (3.3'-to-6.6') wide terrace, to a ditch 1 meter (3.3') wide and about 10–20-cm (4"-8") deep. A bladed road truncates the west end of A2, where it may have been contiguous with the northern extent of A1. The active acequia, 1-to-2-m (3.3'-to-6.6') above this ditch, is now lined with a narrow concrete channel and is shored by basalt boulders in some places (Figures 5 and 6). The east end of A2 is either truncated by recently terraced fields, or merges with the active acequia. The dam for this ditch may have been located at or near an alignment of basalt boulders and an erosion control feature now designated Features 38 and 39 (Figures 5 and 6).

Figure 5 . Concrete lined acequia above abandoned ditch A2. Photo by J. Robert Estes, 2007.

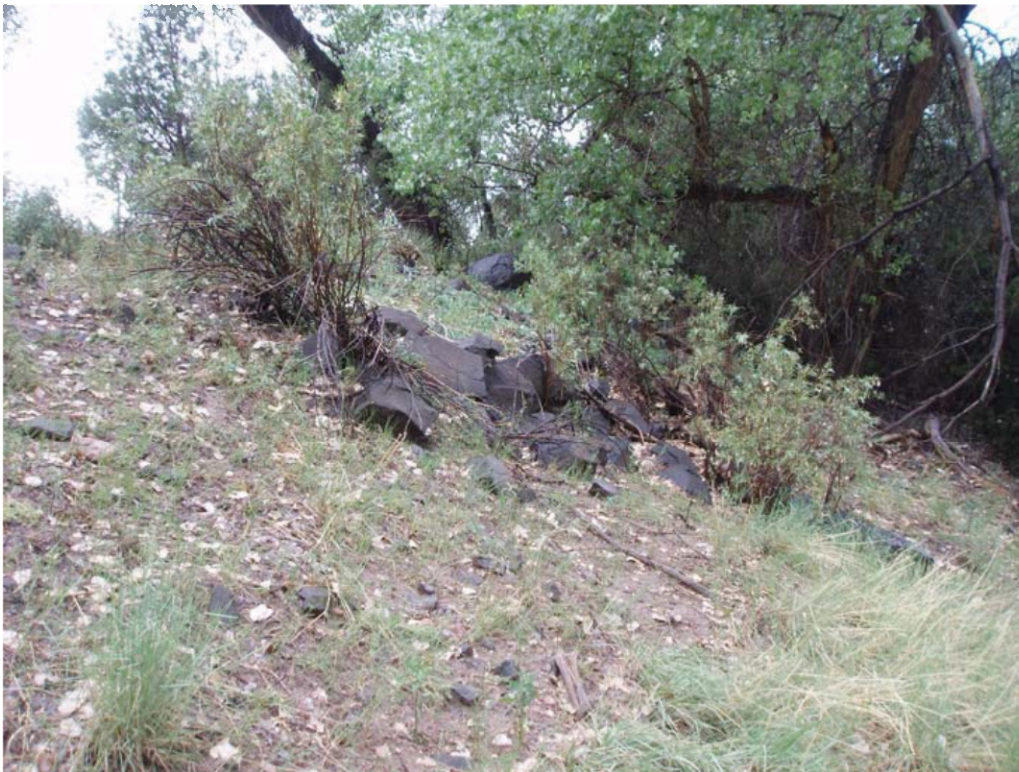
Figure 6. Basalt rock shoring on ditch bank above abandoned acequia A2. Photo by J. Robert Estes, 2007.

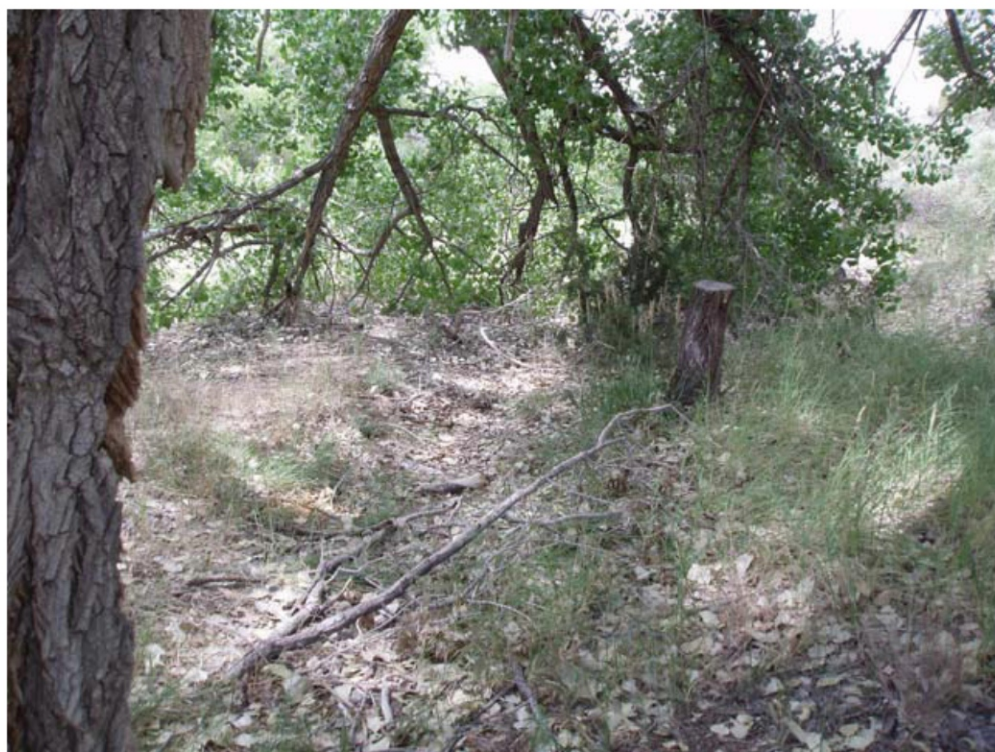
Abandoned Acequia A3 is parallel to the active acequia on the El Rancho de las Golondrinas property (Figure 7). This ditch is a shallow discontinuous swale about 1-to-2-m (3.3'-to-6.6') wide and about 126 m (413') long. It originates at the east end of the Los Golondrinas property and terminates near the small grist mill. The ditch bank for A3 forms the north bank of the active acequia. Grasses, weeds, and trees obscure the details of A3, but the alignment is easily passable on foot. The east end of A3 ends at the north end of the Las Golondrinas property, where Arroyo Hondo bends to the north thereby creating only a narrow band of irrigable land. The west end is truncated by a bladed road on Las Golondrinas property. Runoff from higher ground has filled in or washed-out short portions of A3.

Figure 7. Abandoned ditch segment A3. Photo by J. Robert Estes, 2007.

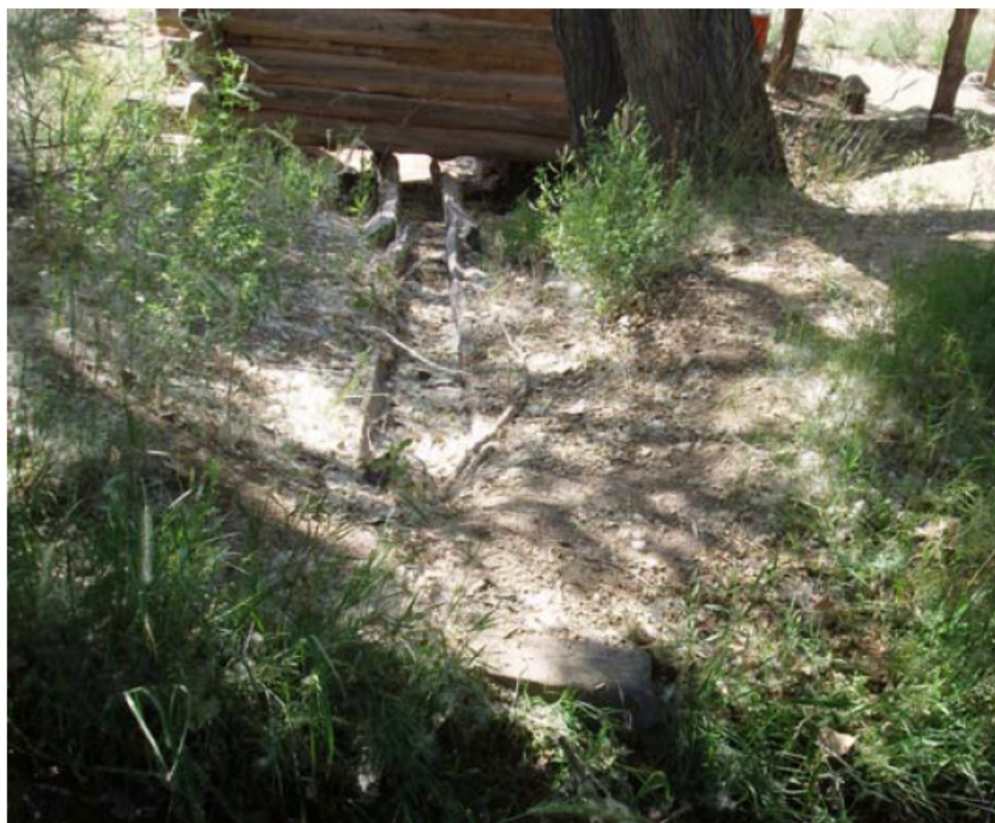
Figure 8. Feature 13, *canoa* to Talpa Molino. Photo by J. Robert Estes, 2007.

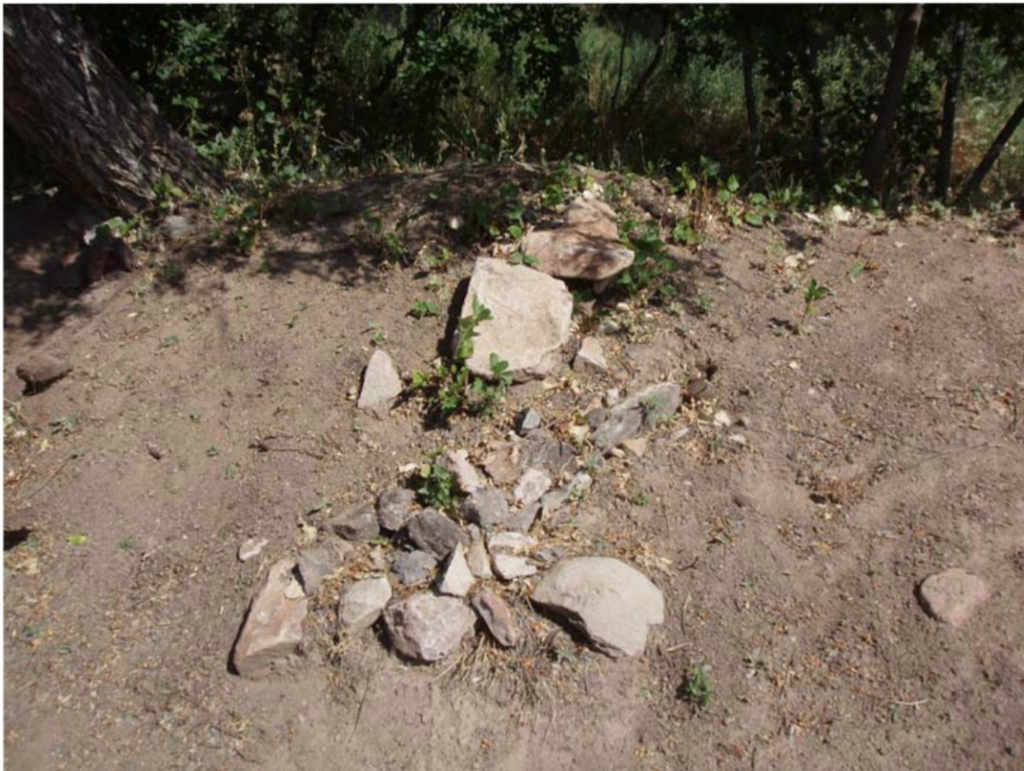
Figure 9. Feature 15 erosion control feature on ditch bank. Photo by J. Robert Estes, 2007.

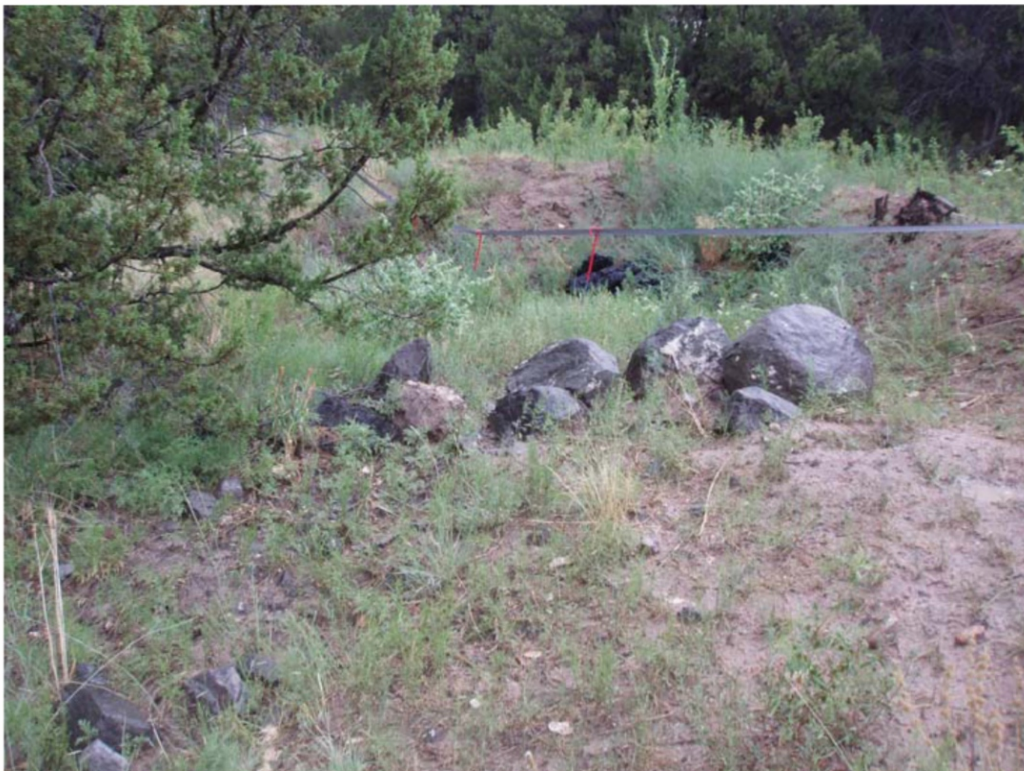
Figure 10. Feature 38, boulder alignment, possible remains of dam on A2. Photo by J. Robert Estes, 2007.

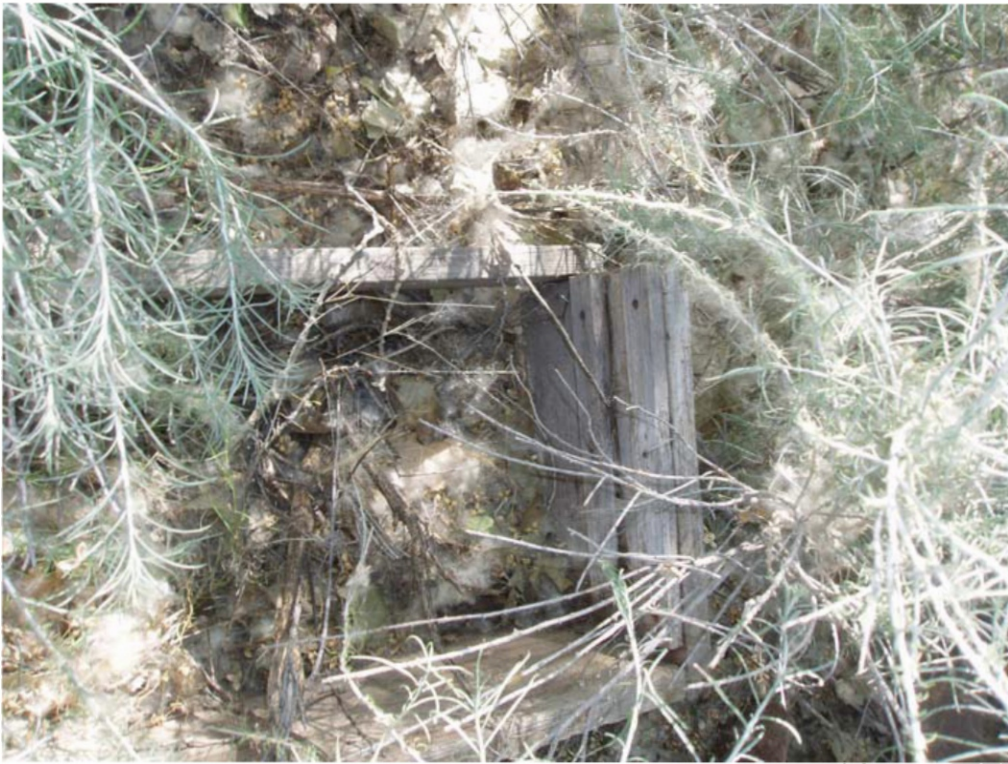
Figure 11. Wood frame tapbox, abandoned. Photo by J. Robert Estes, 2007.

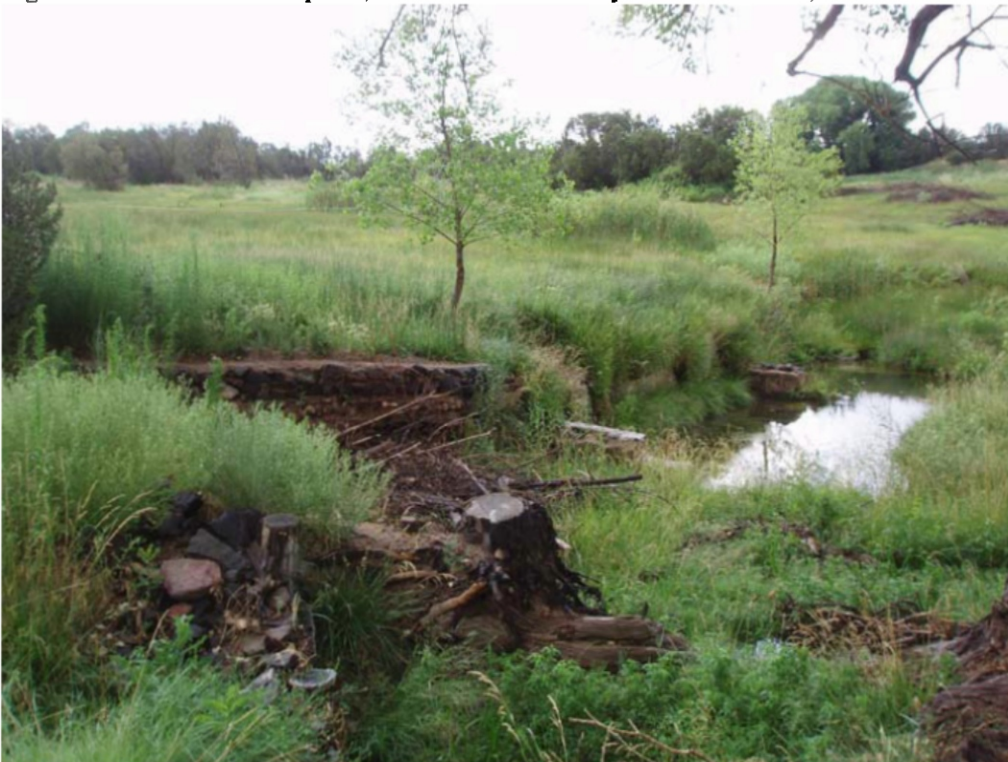
tolerant crops. Finally, the abandoned dam at the head of La Cienega Acequia and de los Tanques Acequia has been replaced by a *compuerta* (Figure 12).

Figure 12. Abandoned *presa* on Arroyo de Los Tanques Feature 41. Photo by J. Robert Estes, 2007.
